NACA RM A53G22

RESEARCH MEMORANDUM

CORRELATION OF FLIGHT AND WIND-TUNNEL MEASUREMENTS OF

ROLL-OFF IN LOW-SPEED STALLS ON A 35°

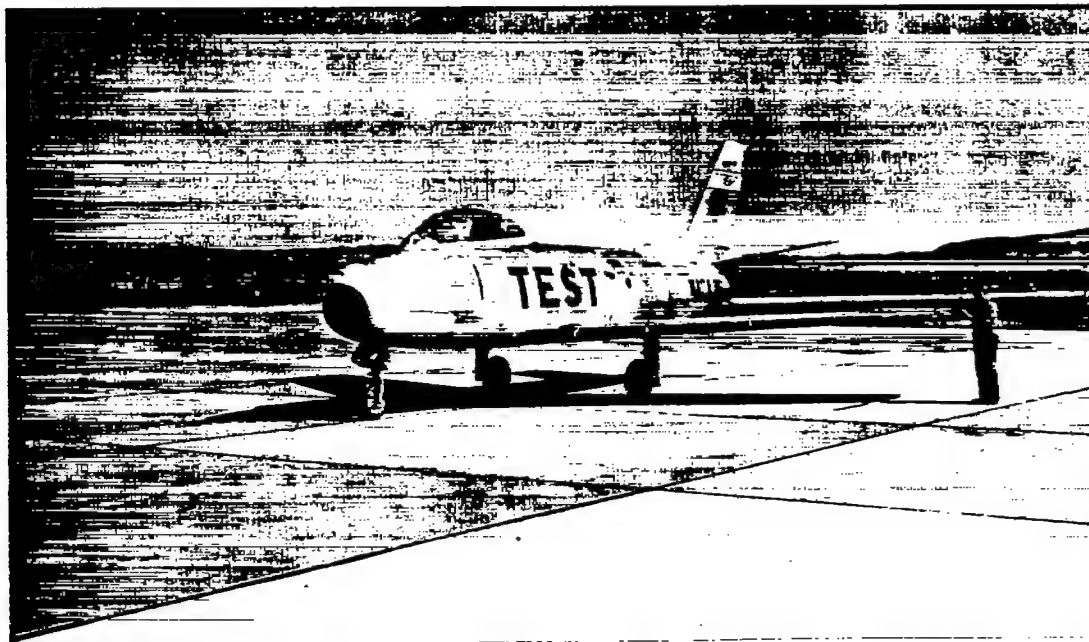
(a) Airplane tested in flight.

Figure 1.- Photographs of test airplane.

The tests were conducted on a jet-powered fighter aircraft having sweptback wing and tail surfaces. Photographs of similar test airplanes as prepared for flight and wind-tunnel tests are presented in figures 1(a) and 1(b), respectively. Figure 2 is a two-view drawing of the airplane. A description of the geometric details of the airplane is given in table I.

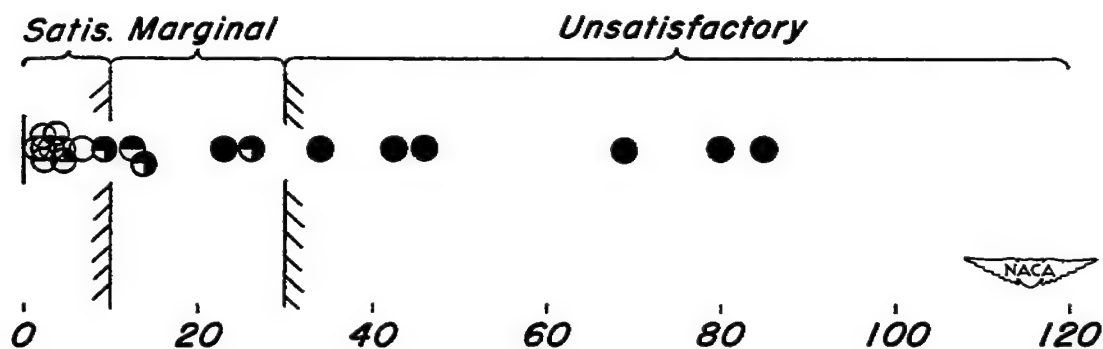
(a) Maximum bank angle resulting from initial roll-off, ϕ , deg.

(b) Maximum rolling velocity resulting from initial roll-off, $\dot{\phi}$, deg/sec.

Figure 3.- Correlation of pilots' opinions of stall with various parameters.

the stall. This correlation of pilots' opinions with behavior in the complete stall is similar to a study previously made (ref. 2) for stall warning in which pilots' opinions of stall warning were correlated with quantitative factors producing the warning. It appeared that the primary factors which could influence the pilots' opinions in the complete stall were the initial bank angle inadvertently attained and the maximum rolling velocity during the initial roll-off. The initial values of these quantities were examined since it was known that the wind-tunnel balance system would not give representative rolling-moment measurements in the dynamic phase of roll behavior occurring later in the stall. A correlation of these quantities with pilots' opinions is shown in figure 3. These results show that a bank angle of the order of 10° or less and a rolling velocity of 10° per second or less represented a satisfactory stall, while values of angle of bank of 30° or more and rolling velocities of 30° per second or more represented unsatisfactory stall behavior. These values are in accordance with those presented in the German flying-qualities requirements of reference 3 and those proposed for military aircraft in reference 4. The German requirements specify, however, a time duration of 10 seconds of stalled flight for which $\pm 30^\circ$ bank angle should not be exceeded, while the results in figure 3 are presented only for the initial angle of bank at the start of the stall.
